INDOOR AIR QUALITY ASSESSMENT

**Department of Revenue
436 Dwight Street (State Office Building)
Springfield, MA**

Prepared by:
Massachusetts Department of Public Health
Bureau of Environmental Health
Indoor Air Quality Program
November 2016

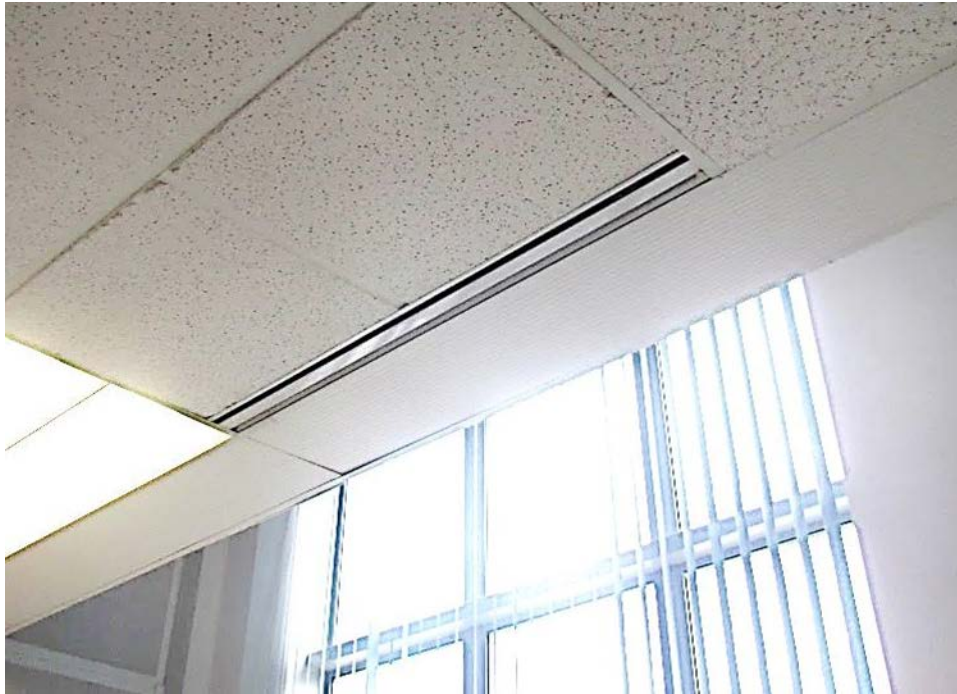
Picture 1

Fresh air is provided by air handling units (AHUs) located on the roof. Air from the AHUs is filtered, heated/cooled, and delivered to rooms via ducted supply vents (Picture 1). Air is returned/exhausted through vents in the ceiling (Picture 2).

Vent for supply air

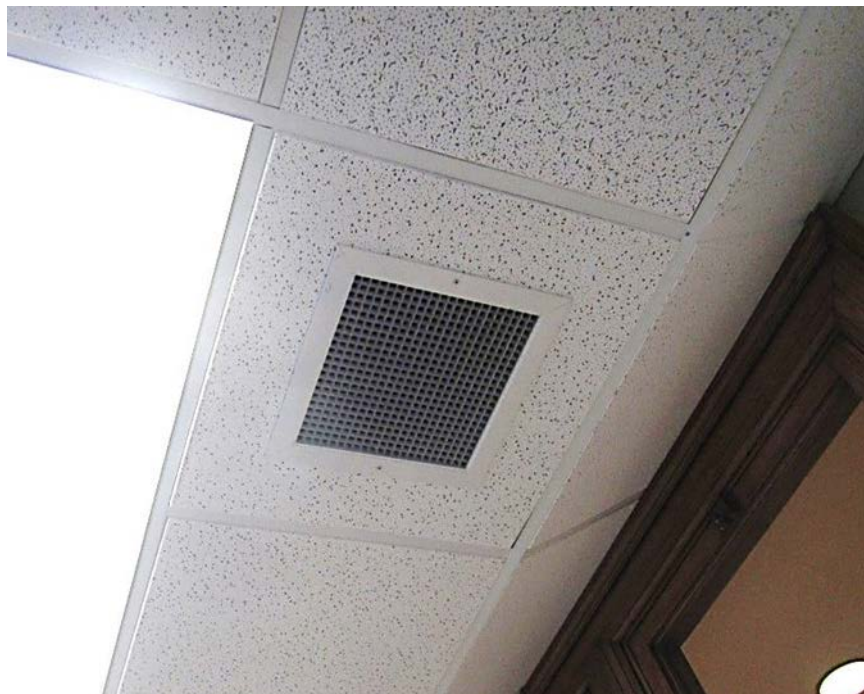
Picture 2

Typical exhaust vent

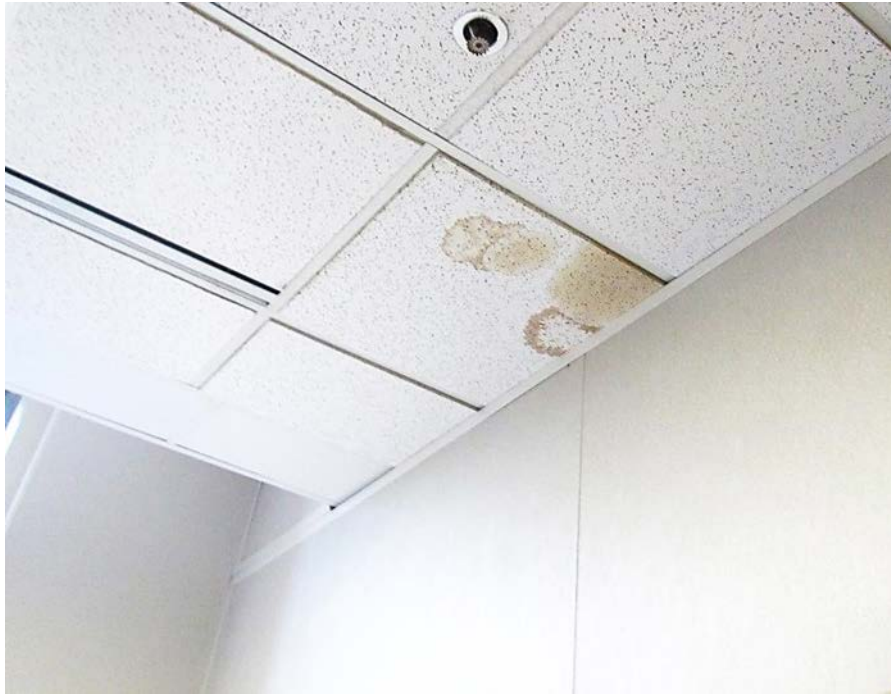
Picture 3

A few water-damaged ceiling tiles were observed on the 4th floor (Picture 3). The conditions causing the leak (e.g., roof leaks) should be fixed, and the tiles should be replaced.

Water-damaged ceiling tiles

3. Repair conditions leading to water-damaged ceiling tiles, and replace the tiles.
4. Keep indoor plants in good condition, avoid overwatering, and avoid placing them on porous items such as carpets or paper. Also, keep plants out of the air stream of supply vents.

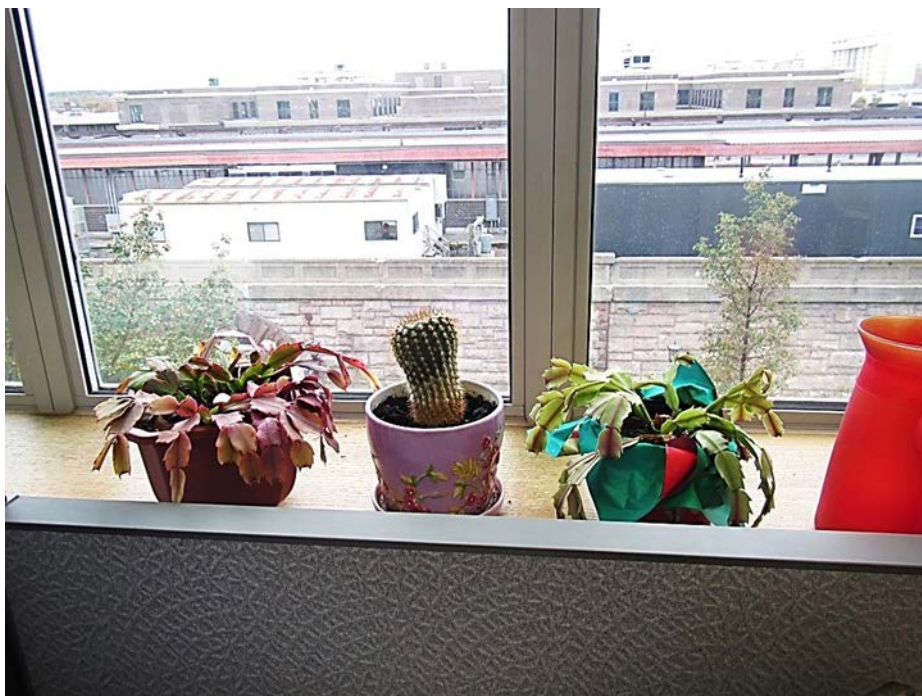
Picture 4

Plants were observed in office areas (Table 1; Pictures 4 and 5). Plants can be a source of pollen and mold, which can be respiratory irritants to some individuals. Plants should be properly maintained and equipped with drip pans to prevent water damage to porous materials. Plants should also be located away from air diffusers to prevent the aerosolization of dirt, pollen, and mold.

Plants on a windowsill

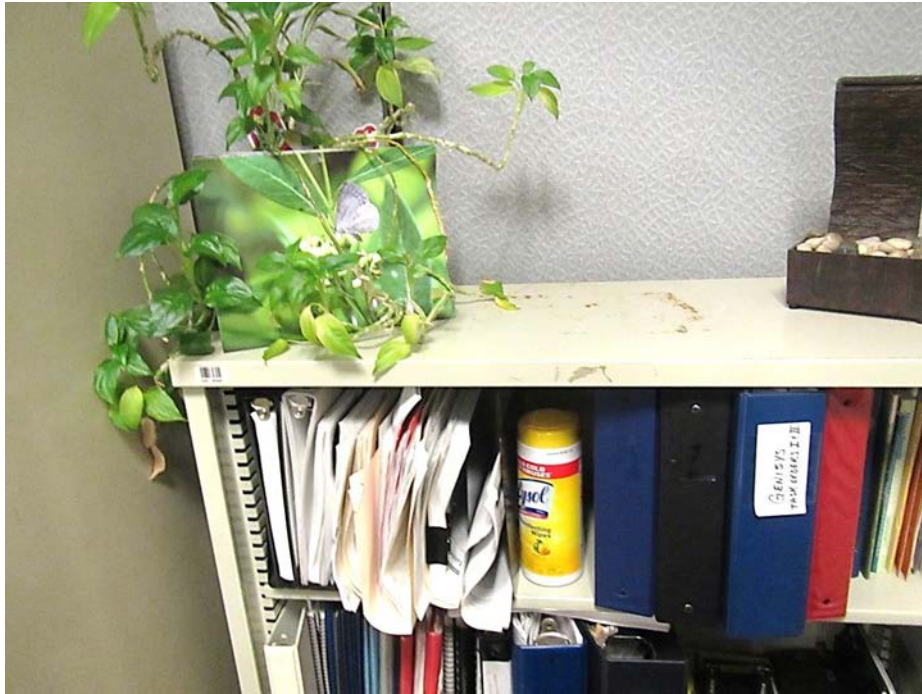
Picture 5

Plant on a bookshelf, note water stains

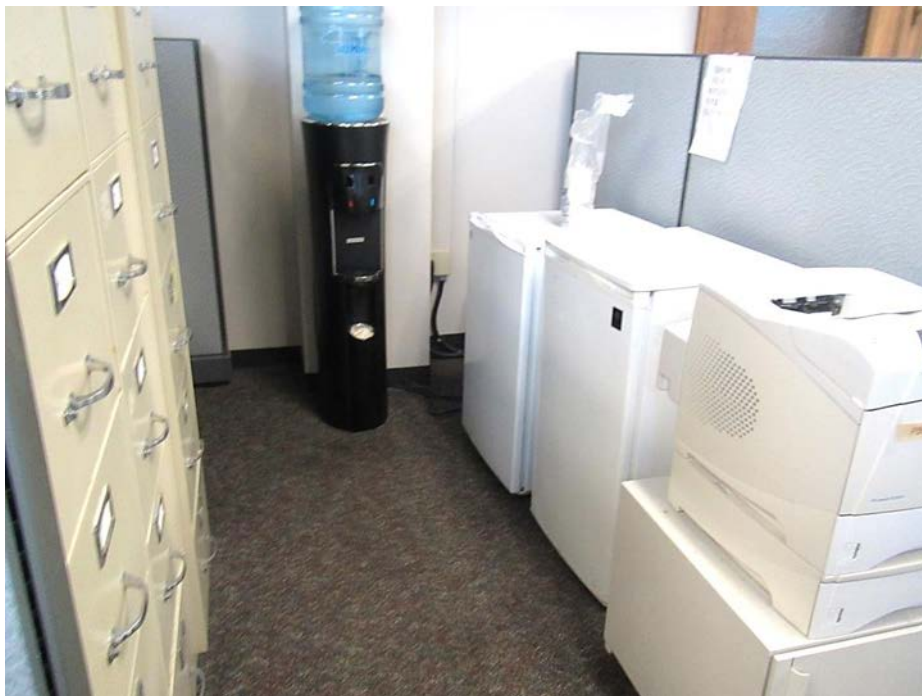
Picture 6

Small refrigerators and water dispensers were observed in carpeted areas (Pictures 6 and 7). These appliances may spill or leak and lead to carpet damage and microbial growth. It is recommended that these appliances be located in areas without carpeting or on waterproof mats. Carpet squares could also be replaced with tile in areas where water dispensers and refrigerators are located. Some of the refrigerators were crowded with items or had evidence of spills/crumbs. Refrigerators should be kept clean to prevent odors and microbial growth.

Water dispenser and two refrigerators on carpet

5. Consider locating refrigerators and water dispensers in non-carpeted areas or place on a waterproof mat.
6. Clean refrigerator spills promptly and clean refrigerators out regularly to avoid odors and microbial growth.

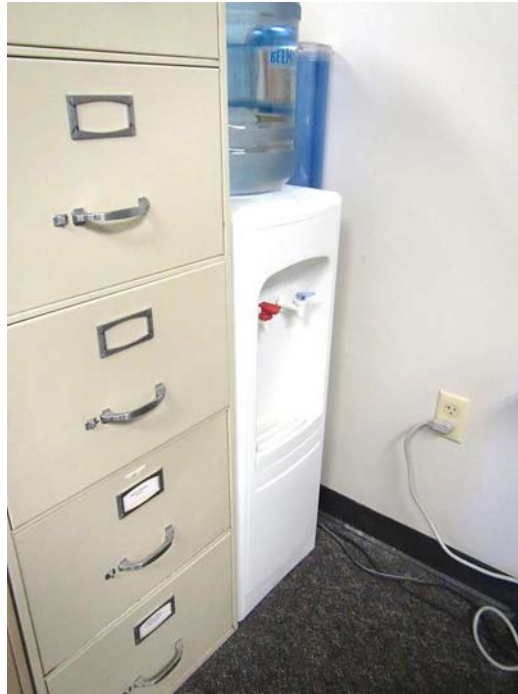
Picture 7

Water-dispenser on carpet in hard-to-reach area

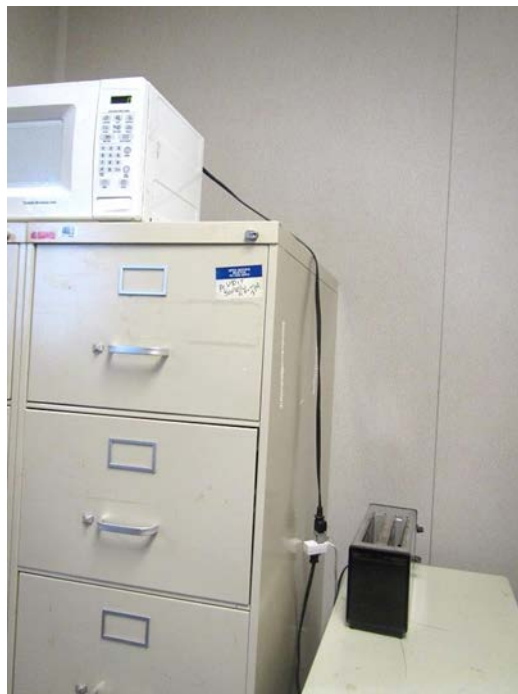
Picture 8

Cooking equipment, including toasters, microwave ovens and coffee machines were located in various parts of the office space (Pictures 8 and 9). The presence of so many different pieces of cooking equipment near workstations and without direct exhaust ventilation increases the chance of food odors permeating office areas. Food areas and cooking equipment need to be kept clean to prevent odors and pests. Carpeting in these areas may trap crumbs and spills as well. Consider consolidating cooking areas into unoccupied and uncarpeted areas or protect the carpeting in these areas with a mat.

Microwave and toaster on top of office furniture

7. Ensure cooking areas/equipment are kept clean to prevent odors and pests. Consider reducing the number of areas where food is stored and locating them away from occupied areas.

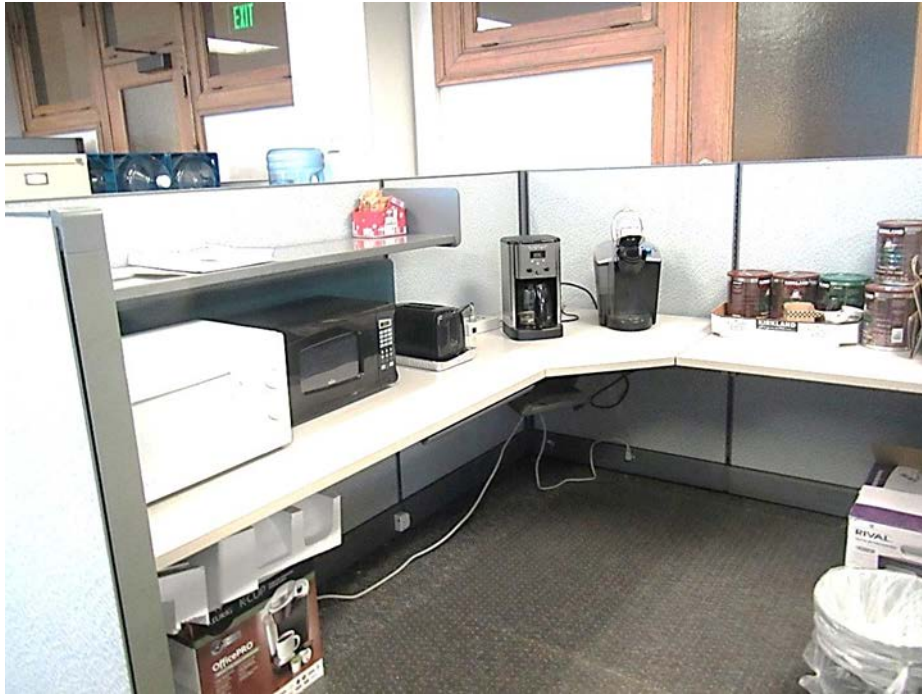
Picture 9

Cooking equipment in office area

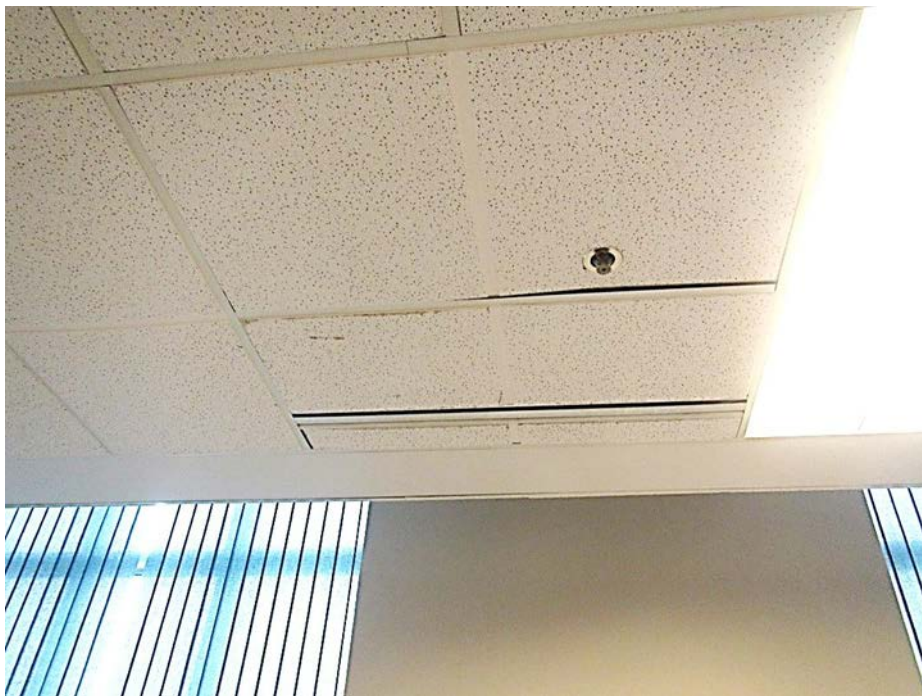
Picture 10

Some of the supply vents were observed to be set in ajar ceiling tiles (Picture 10). This may indicate that the tiles are not quite cut to fit around them properly, or that the plenum is pressurized. Missing and ajar tiles were observed in a few other areas as well (Picture 11). These conditions can lead to debris from the plenum space entering into occupied areas.

Ajar tile next to vent

15. Ensure missing ceiling tiles are replaced and that all tiles fit snugly into the ceiling tile system to prevent debris from the plenum from entering occupied areas.

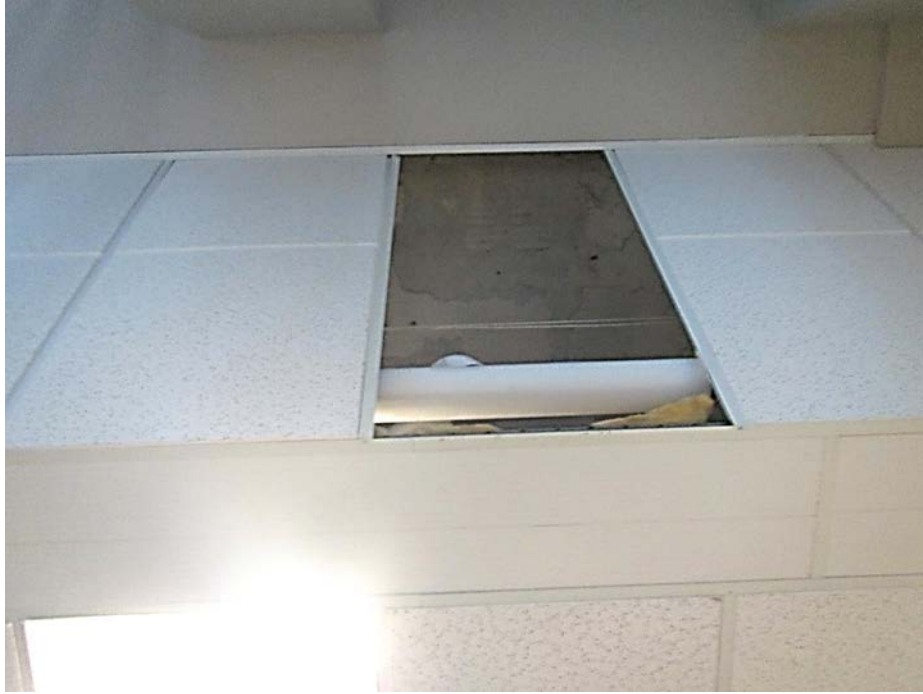
Picture 11

Missing ceiling tile (on side along windows)
